discussion of construction
issues and techniques

Tendon Repairs and Modifications

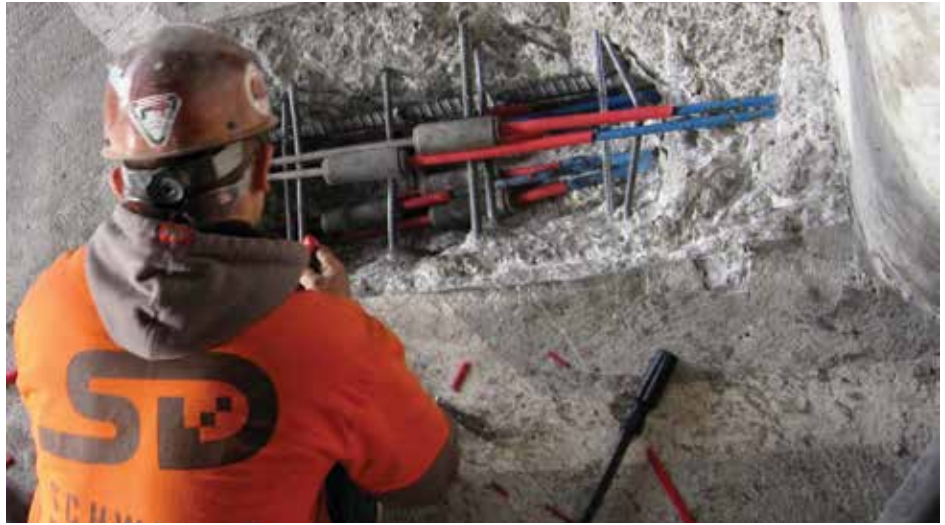
Figure 1. Worker repairs parking garage slab PT strand with couplers.

The first step in construction is to locally shore the work area and to chip away the concrete to expose the broken tendons (Figure 1). This must be done with care to avoid damaging adjacent tendons. In most situations, a single broken tendon will be repaired with a splice and re-tensioned rather than entirely replaced. However, if the tendon shows rust or other material damage, it will need replacement.

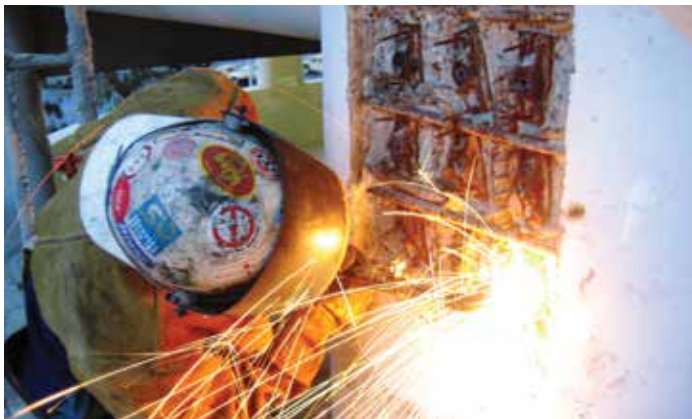
Figure 2. PT worker detensioning a tendon to prepare for strand replacement.

Once planning, blocking, de-tensioning, cutting, and demolition are complete, the tendons are replaced or spliced with appropriate anchors, in a manner similar to that for the single tendon project, and the slab is reconstructed. *Figure 2* shows the de-tensioning of the tendons at the end of a beam. The process of slab tendon de-tensioning is similar. A safety item to note is that slab ends must be guarded with perimeter blocking (typically with a heavy wood or steel beam) when the tendons are first cut. The force released by a cut tendon may cause the tendon to break through its grout cap and pose a threat to nearby people or equipment. The contractor must ensure that, before any cutting takes place, safety blocking protects any strand ends that might release force. Once the detensioning and demolition are complete, the

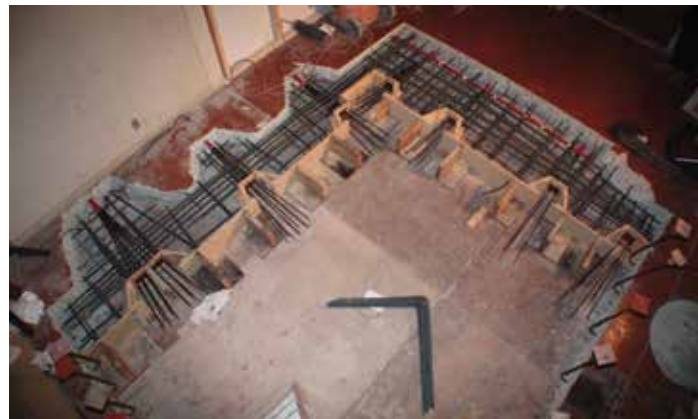
Figure 3. Slab opening with antiquated button-headed wire system.

profile of the tendons can also be adjusted within the work area to address the new structural spans and geometry. Once the tendon work is finished, including the addition of new end anchorages, the concrete floor slab is recast with rebar reinforcement (*Figure 3*). Bonding agents help rapid set repair mortars tie into the existing slab. The slab opening may call for a turned down beam to rim the cutout for reinforcement, aesthetic look, or other mounting needs (such as serving as an anchor for railing attachments). Once the concrete cures, tendons are re-tensioned as in new construction (*Figure 4*), and the cutout is ready for new service (*Figure 5*).

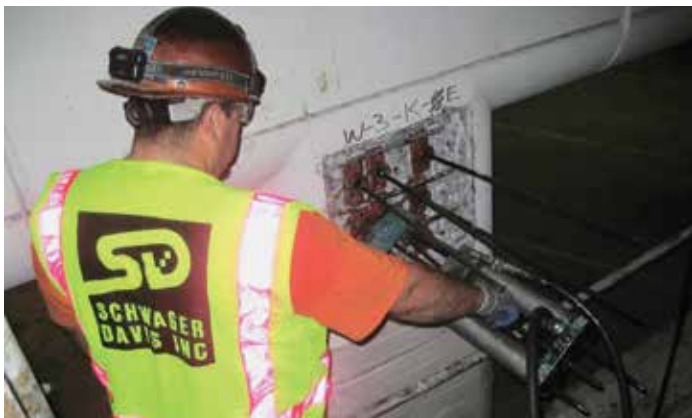
Figure 4. Worker re-tensions a repaired strand.

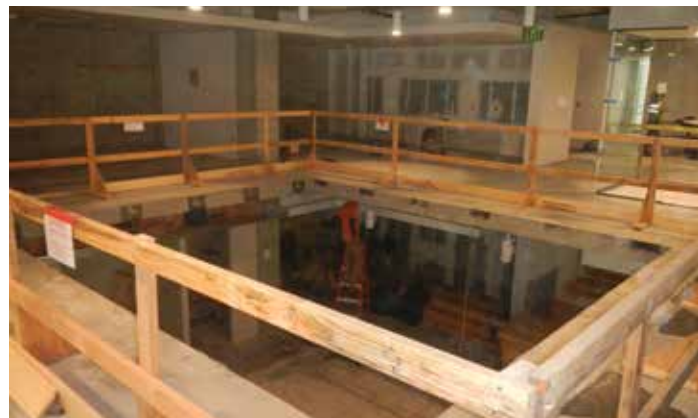
Figure 5. A successful PT slab cutout for a new staircase.
